Viewpoint

Slip sliding away

Folkestone Warren, East Cliff, Folkestone, Kent

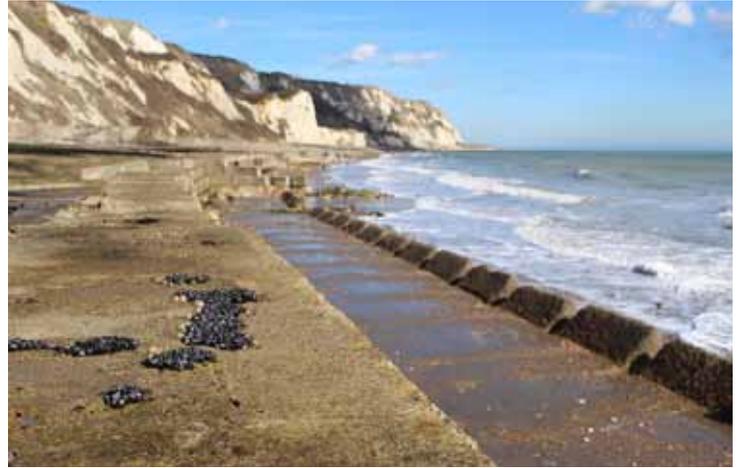
Slip sliding away: Edwardian holiday makers board a train at Folkestone Warren Halt (left) and today's coastal defences (right)

Look down at the large grey concrete area on the beach. Between 1948 and 1955, massive concrete 'aprons', a series of groynes and rock armour were put in place along the coast here. The sheer bulk of these concrete platforms stops the cliff slipping out to sea. The groynes limit the amount of material being washed away from the beach leaving the cliffs unprotected from the sea.
